Manhole Inspection Summary

Manhole # S690__021MH

Insp Date: **2/6/08 1:17 PM**

Location Address: **6709 Gary Ave.**

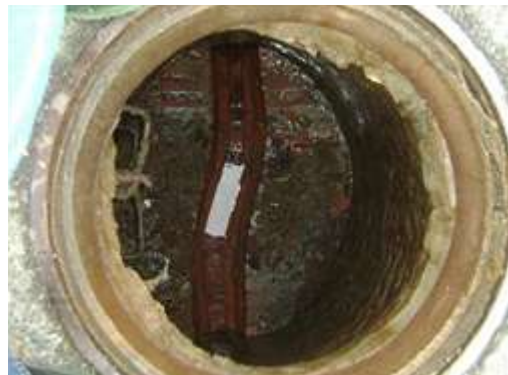
Top View

Condition: ☐ Sound ☐ Cracked ☐ Root Intrusion ☒ **Loose Brick** ☐ Deteriorated

Infiltration: ☐ None ☒ **Joint** ☐ Cracks ☐ Mortar ☐ Roots ☐ Wall

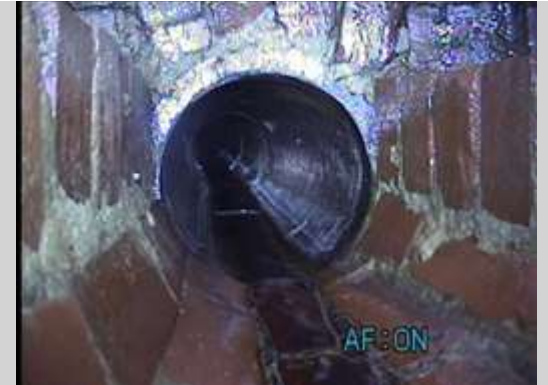
12 O'Clock Outflow

8 in. Circular Gravity Sewer
Pipe Out @ 12 O'Clock

Pipe Height: **8.4** (in.) Rod and Bar (Angled)
Pipe Material: **Clay** ☐ Pipe Lined
Invert Depth: **8.00** (ft.) Flow Characteristics: **Slow**
Deposits: ☒ None ☐ Mud ☐ Sludge ☐ Debris ☐ Grease
Silt Depth: (in.) Deposits Extent:
Infiltration: **None** Pipe Seal Cond: **Sound**

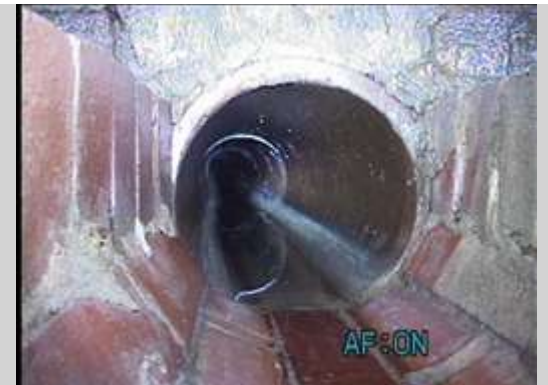
6 O'Clock Inflow

8 in. Circular Gravity Sewer
Pipe In @ 6 O'Clock

Pipe Height: **8.4** (in.) Rod and Bar (Angled)
Pipe Material: **Clay** ☐ Pipe Lined
Invert Depth: **7.92** (ft.) Flow Characteristics: **Slow**
Deposits: ☒ None ☐ Mud ☐ Sludge ☐ Debris ☐ Grease
Silt Depth: (in.) Deposits Extent:
Infiltration: **None** Pipe Seal Cond: **Sound**
